Case Report

Entrapped hydrophilic coat of short guide wire- A potential rare complication of vascular access site.

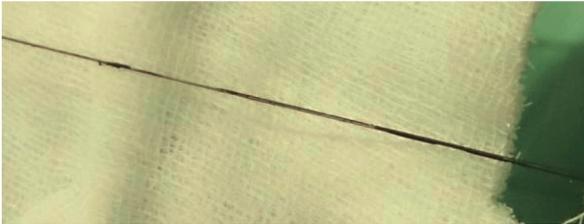
On attempting to advance the sheath it was noted that the outer hydrophilic coating of the guide wire was peeling off the sheath in a circumferential manner on pushing the introducer (Figure 01). At this time similar damage to the distal portion of the guide wire was suspected. It was planned to stop the sheath insertion and to screen the hand for possible hydrophilic coating entrapment at or near the radial puncture site.

Figure 1- Peeled of hydrophilic radial short guide wire during retrieval after radial sheath insertion

This case further highlights a potential complication when the hydrophilic wires have been reused with chemical sterilization, which may lose its original properties and thus this practice is actively discouraged.

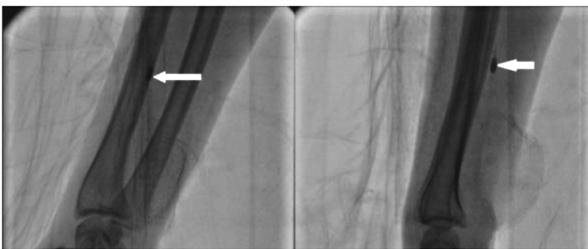
The Cine radiography showed a plug of radio opaque material at distal radius which was well above the bony plane suggesting that it may be either intra luminal or subcutaneous foreign body entrapment of consisting the hydrophilic coating (Figure 02).

Figure 2- Radio opaque entrapped hydrophilic coat at the radial access site at radial vascular plane

Procedure was abandoned, and the distal tip of the guide wire was slowly withdrawn into the sheath while both the sheath and guide wire were withdrawn gradually out from radial artery.

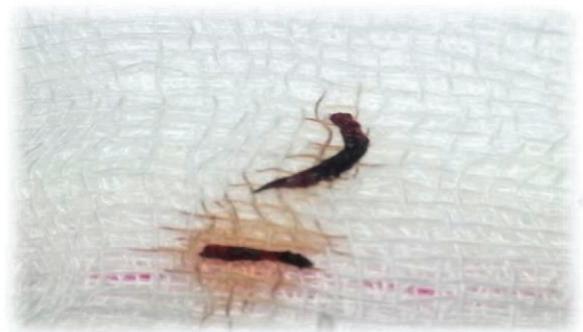
Further analysis of the removed guide wire confirmed the peeled off segment of the distal tip of the guide wire in a circumferential manner leaving the metal tip exposed (Figure 03). Doppler study of the radial and ulnar arteries confirmed the blocked radial artery with minimal blood flow distal to this foreign body entrapment and a good ulnar collateral circulation rescuing this distally impaired radial flow.

The decision was made to retrieve the lost fragment by local surgical approach under local anesthesia. Two cylindrical shaped, floppy, foreign materials which had showed radio opaqueness on cine screening confirming the peeled off hydrophilic coating of the guide wire was retrieved. Further hospitalization was uncomplicated. He had post op good distal radial flow on clinical and Doppler assessments.

Figure 3- Surgically retrieved hydrophilic coat materials of the guide wire

Hydrophilic coat entrapment of a short guide wire at radial artery access sites has not been documented so far. This case further highlights the risk of potential complications in poor resource and high patient demand centers where the hydrophilic wires have been potentially reused with a chemical sterilization which could cause loss of its original properties.
